Another Problem Solved by PipeServ

Location: Sulphuric Acid Plant - Australia

Application: Heat Exchanger

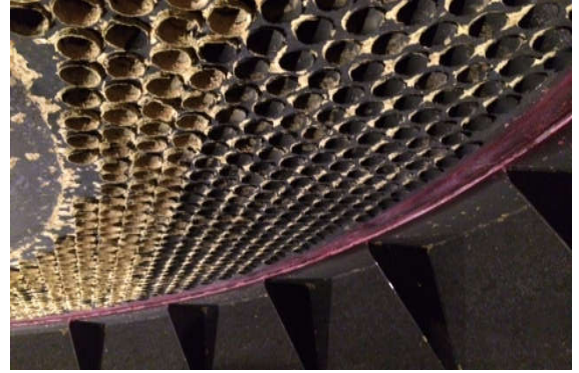
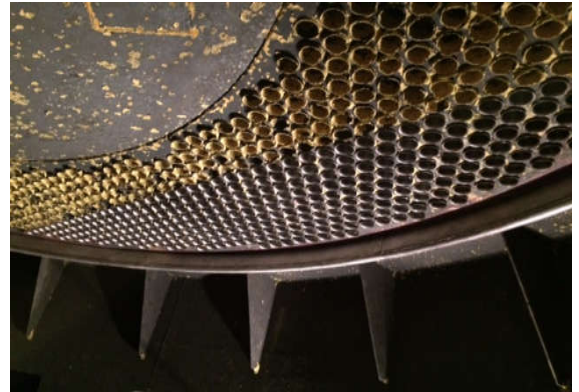
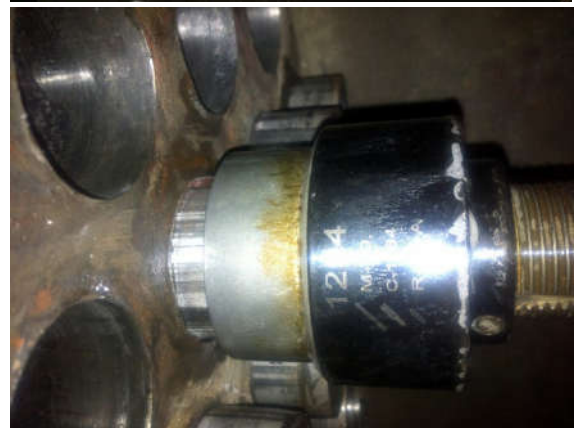
The heat exchanger, converter boiler was a U-Tube style with the bundle consisting of 2310 tubes of a 304SS material. The tube OD was 63.50mm with 2.00mm wall thickness.

Starting on the western side of the tube sheet (opposite side to the cold gas duct) 304 sleeves in total were inserted into the tube ends, hydro-locked and mechanically rolled.

PipeServ recommended to re-sleeve the tube ends and using specialised tooling to hydro-lock individual sleeves into the existing tubes then finish off with mechanically rolling the individual sleeves to meet the specified expansion measurement.
